Geospatial Mapping and Water Quality Index Assessment of Groundwater in Southern Parts of West Godavari District, Andhra Pradesh, India

Abstract- *Groundwater quality is declining across many regions due to natural processes and human pressure. In southern West Godavari District, Andhra Pradesh, India, the area receives heavy seasonal rainfall yet faces persistent water quality problems, largely from intensive irrigation and aquaculture. This study analyzed groundwater quality across 77 villages using GIS-based spatial mapping and a Water Quality Index (WQI). Samples from all 77 sites were tested for eleven physicochemical parameters: pH, TDS, EC, total alkalinity, total hardness, turbidity, calcium, sulphates, chlorides, iron, and fluorides. Spatial distribution maps were produced using ArcGIS 10.2.2 (Spatial Analyst module). WQI was computed at each location to assess seasonal and spatial variation in water suitability. Salinity was slightly elevated at several sites, consistent with the influence of irrigational and aquacultural activity on local groundwater chemistry. Seasonal WQI fluctuations were observed across the study area. The findings give water resource managers a spa

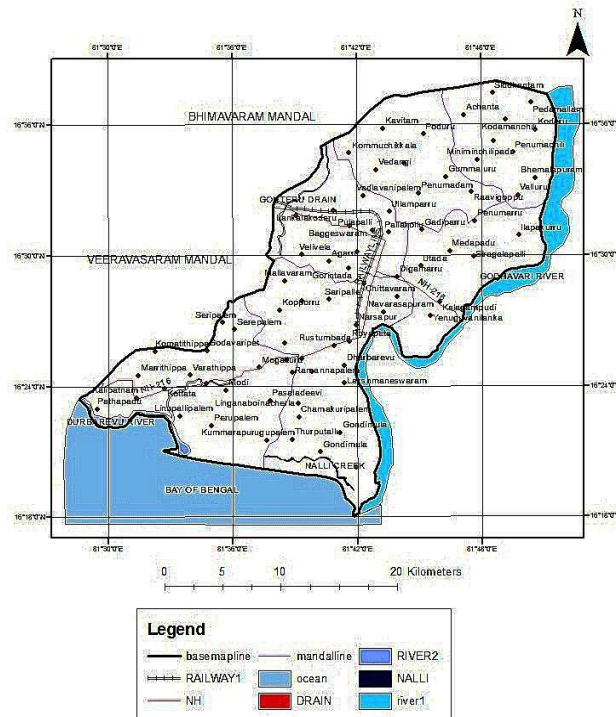
Figure1. Study area map with sampling locations

The study area is situated near to east cost of Andhra Pradesh consisting of six mandals of west godavari district namely Mogalthur, Palakollu, Poduru, Achanta, Yelamanchili and Narsapuram. The

area lies between longitudes 82°10' to 82°21' E and latitudes 16°30' to 17°03' N. The monitoring network in the study area consists of ground water resources like bore wells, tube wells, dug wells. A total of 77 water samples were collected from the study area and analyzed during pre and post monsoon seasons of 2024-25 to understand the behavior of ground water quality. The average annual rainfall in the study area is about 312.2 mm during the study period 2024-25 which is below the average rain fall of 720 mm. These areas get most of its seasonal rainfall from the south west monsoon. The main dominant occupation of the people is agriculture and aqua culture the main crops grown are paddy, sugarcane, groundnut etc. During last few decades, though the study area is an agriculture-based area, intensive fish and prawn culture starts causing groundwater pollution which results water contamination. Therefore, the present study is to draw attention towards taking necessary steps to minimize the adverse impacts likely to occur due to ground water pollution. The description of study area is shown in Fig. 1. The study area is plotted using survey of India toposheet 65H7,65H10,65H11,65H14,65H15 and using ArcGis 10.2.2.

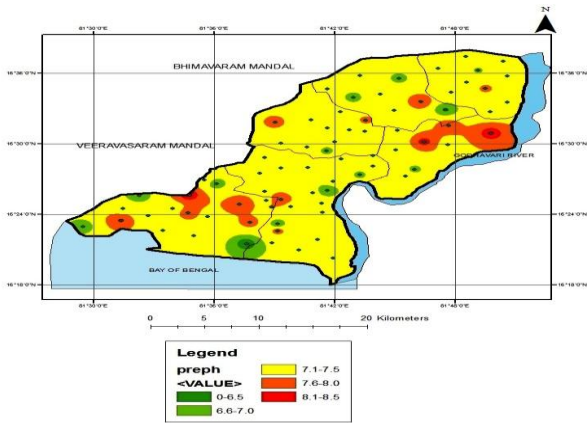
Figure 2: The spatial distribution of pH

In this study the spatial distribution of 12 parameters is calculated and compared with ISO 10500 [8] (Table-3). The spatial distribution of the different water quality parameters are shown in figure 2 to figure 13. The spatial distribution of water quality index (WQI) is shown in figure 14. From figure 2 it is very clear that there is no problem with pH of ground water because in all 77 samples the pH is between 6.5 – 8.5 except one or two locations. The Electrical conductivity is (Figure-3) high at Nallipeta, Seetharamapuram South and Digamaru. The spatial distribution of the Total Dissolved Solids (TDS) shown in Figure-4. According to the findings, few locations namely Nallipeta, Seetharamapuram South, Digamaru, Utada have beyond the maximum permissible limit of 2000 mg/l. Alkalinity shows moderate at centre part of the study area, (Figure-5) high at Ilapakuru, Kavitam, Kalagampudi, Pathapadu etc. The high Turbidity (Figure-6) of water makes the water less acceptable by the public and also interfere with disinfection mechanism and reduce the disinfection efficiency especially of chlorination. The Total hardness parameter (Figure-7) is high at one or two places remaining locations are maintain uniformly throughout the study. The spatial distribution of the calcium is shown in the Figure 8. Almost all locations show the value of calcium between 75-200mg/l. Water quality index has been calculated based on 12 important water quality Parameters (pH, TDS, EC, Turbidity, Alkalinity, Chlorides, Fluorides, Hardness, Calcium, Magnesium, Sulphate and Iron). Figure 14 shows spatial distribution of WQT index. Only one location namely Siddhantam fall under Excellent category. Few areas like Perupalem, Poduru, Gondimula, Kavitam, Sagamcheruvu, Baggeswaram are having a very high-water quality index and unfit for drinking.

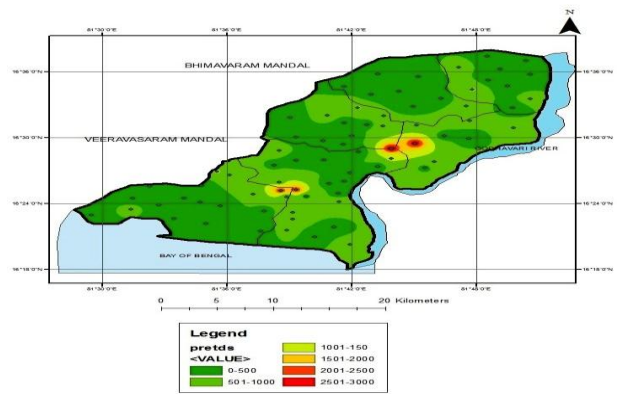
Figure 3: Electrical Conductivity

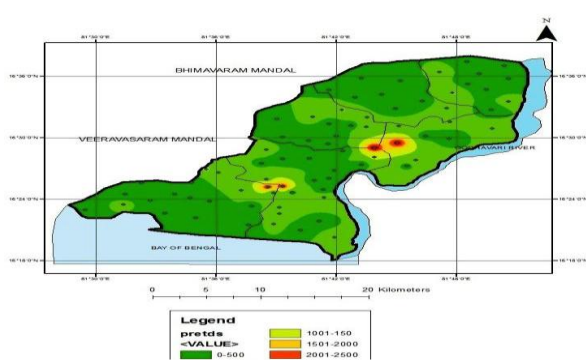
Figure 4: Total dissolved solids (TDS)

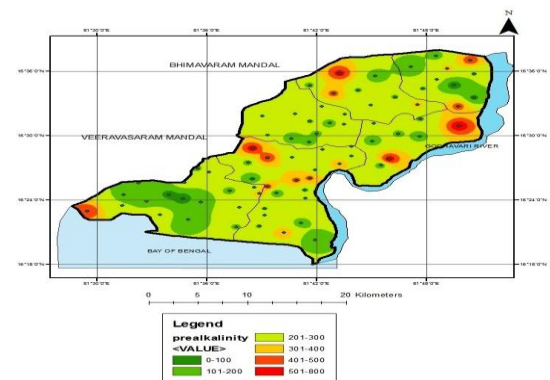
Figure 5: The spatial distribution of alkalinity

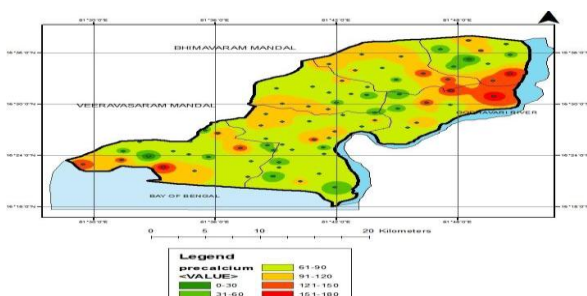
Figure 8: The spatial distribution of calcium

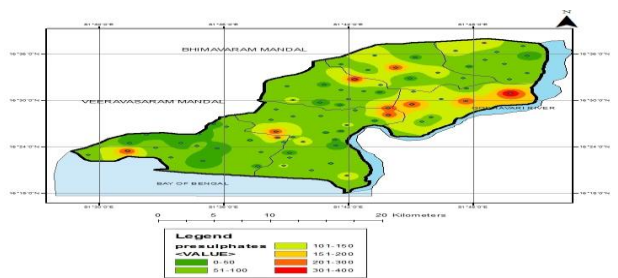
Figure 9: Sulphates

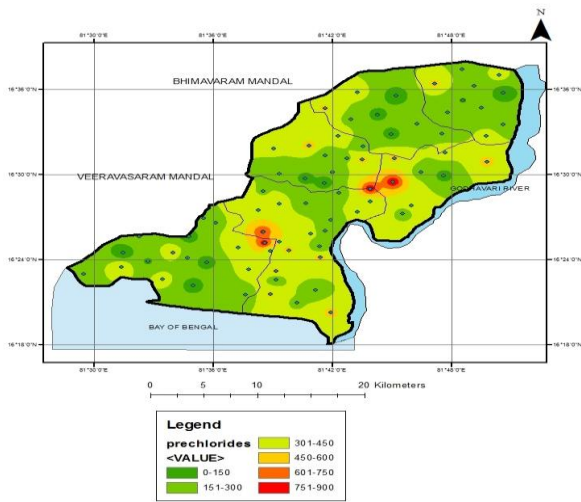
Figure 10: The spatial distribution of chlorides

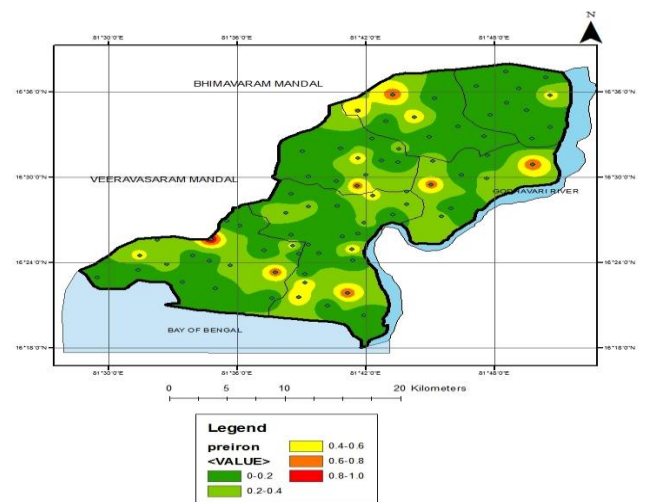
Figure 11: The spatial distribution of iron

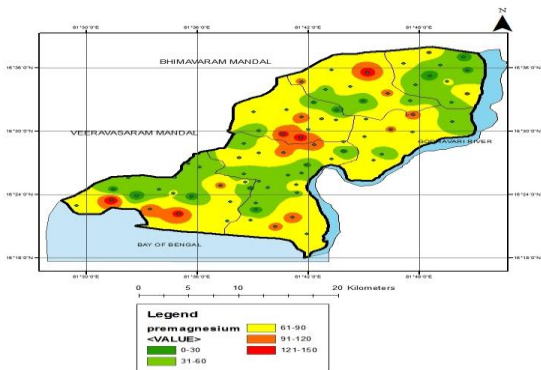
Figure 12: The spatial distribution of magnesium

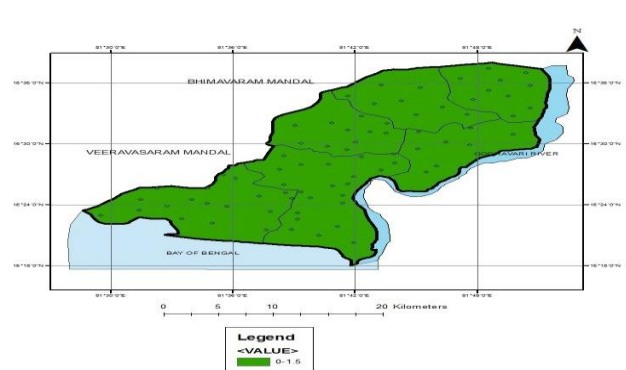
Figure 13: The spatial distribution of fluoride

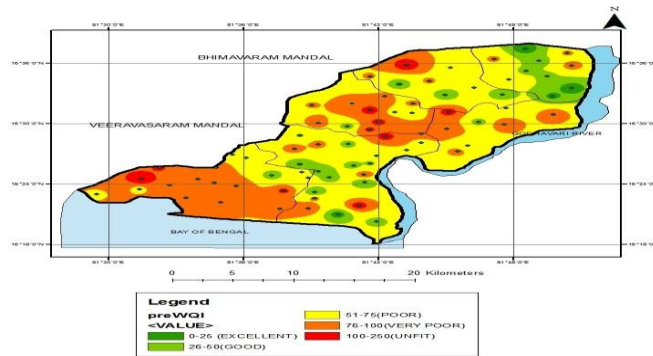
Figure 14: Spatial distribution of Water Quality Index (WQI) in the study area
